Resonon Test Report – Wedge Window Realign

Identification Data		
Date	September, 2019	
Resonon SN	100114-1	
Instrument Name	BS01	
Andor Camera SN	CCD-17878

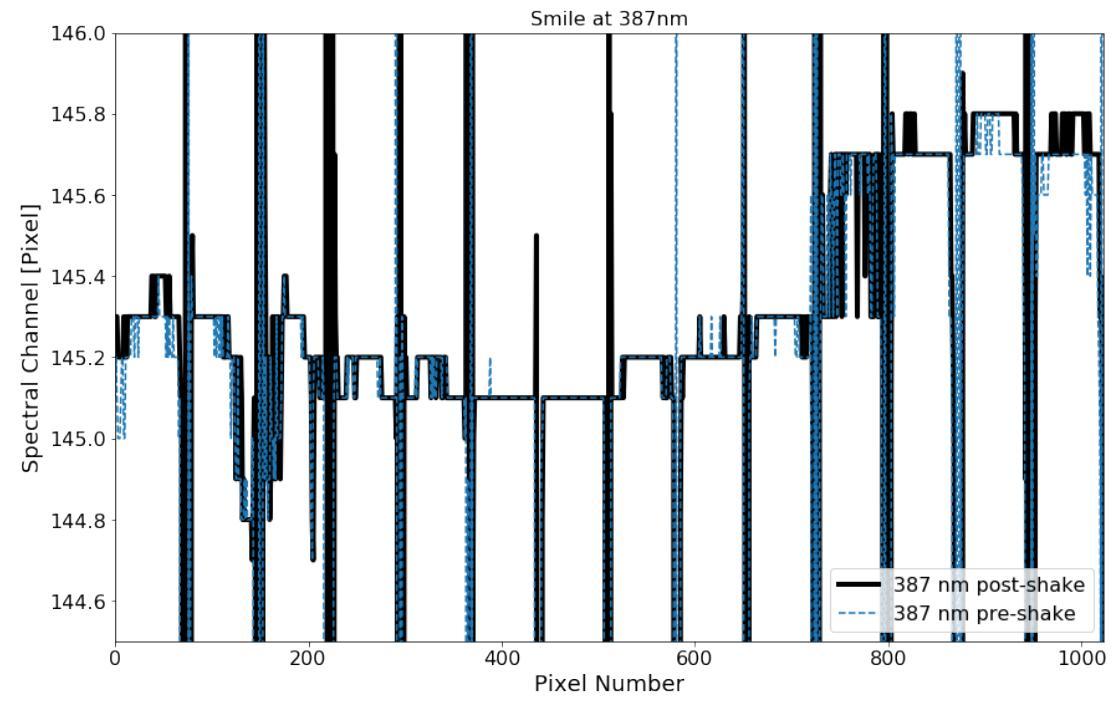
Figure 4: Smile at 387 nm. Horizontal axis is spatial channels and vertical axis is spectral.

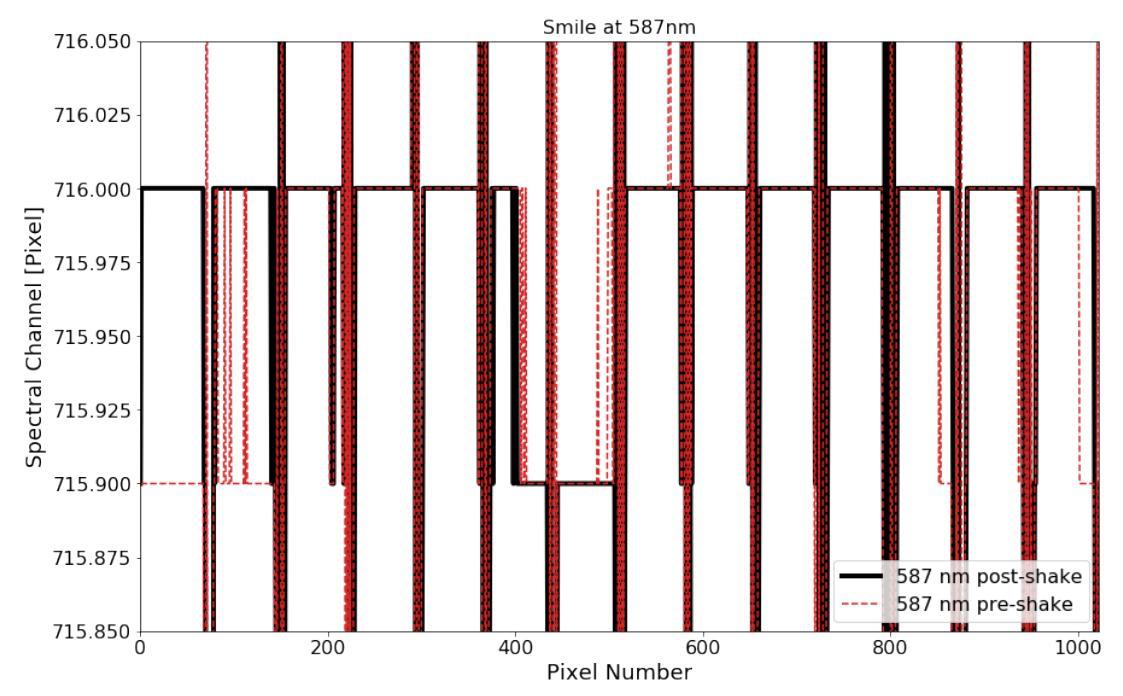
Figure 5: Smile at 587 nm.

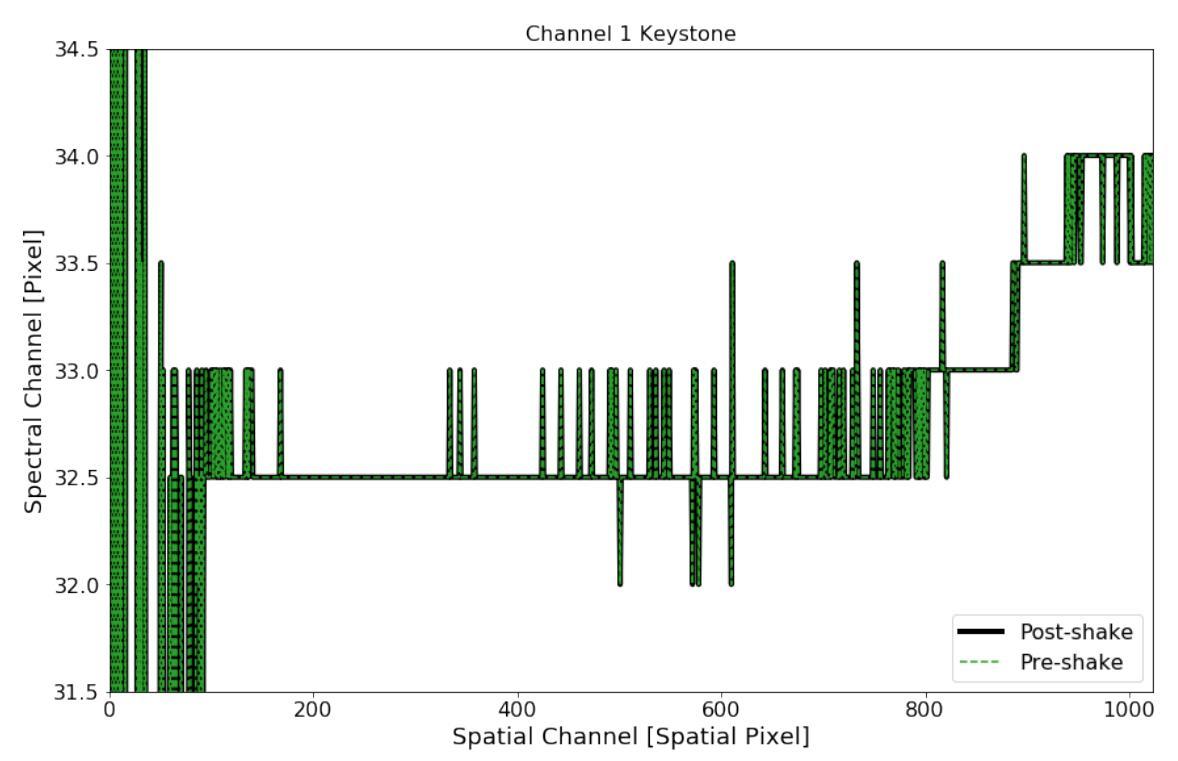
Figure 6: Channel 1 keystone. Horizontal axis is spectral channels and vertical axis is spatial.

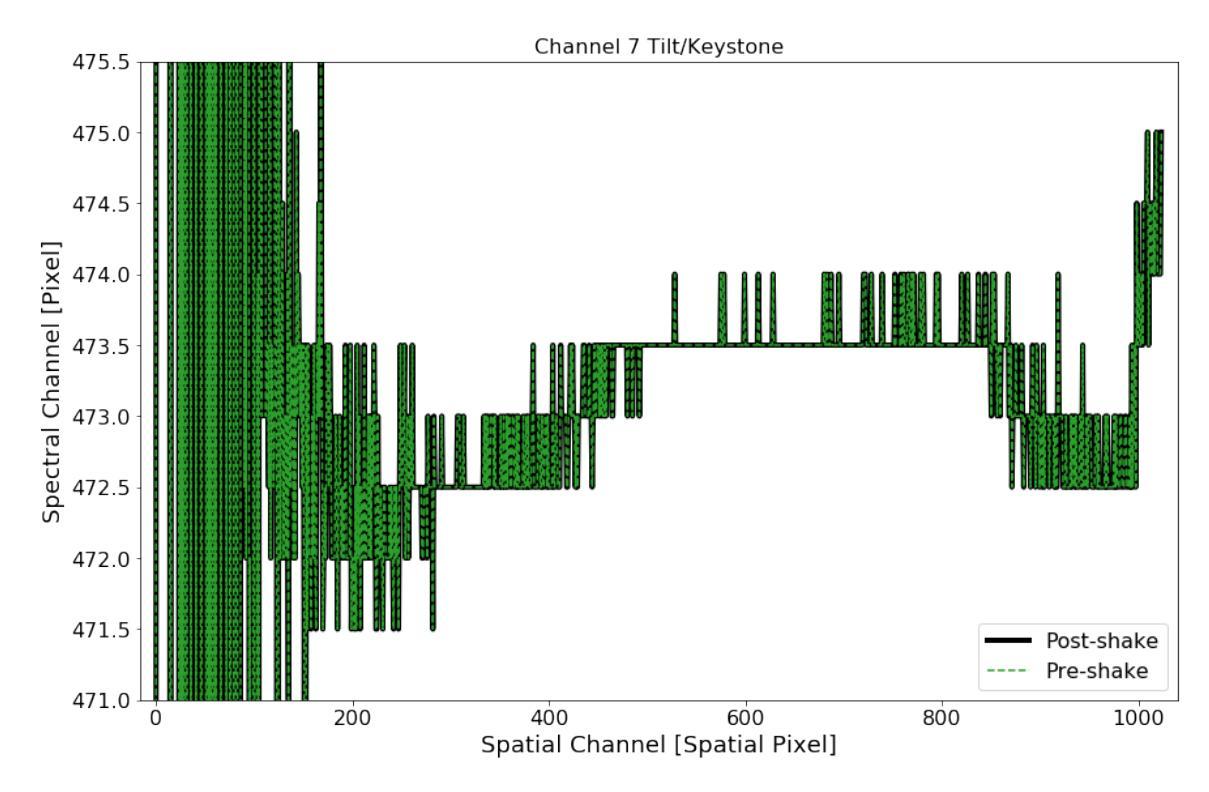
Figure 7: Channel 7 tilt/keystone

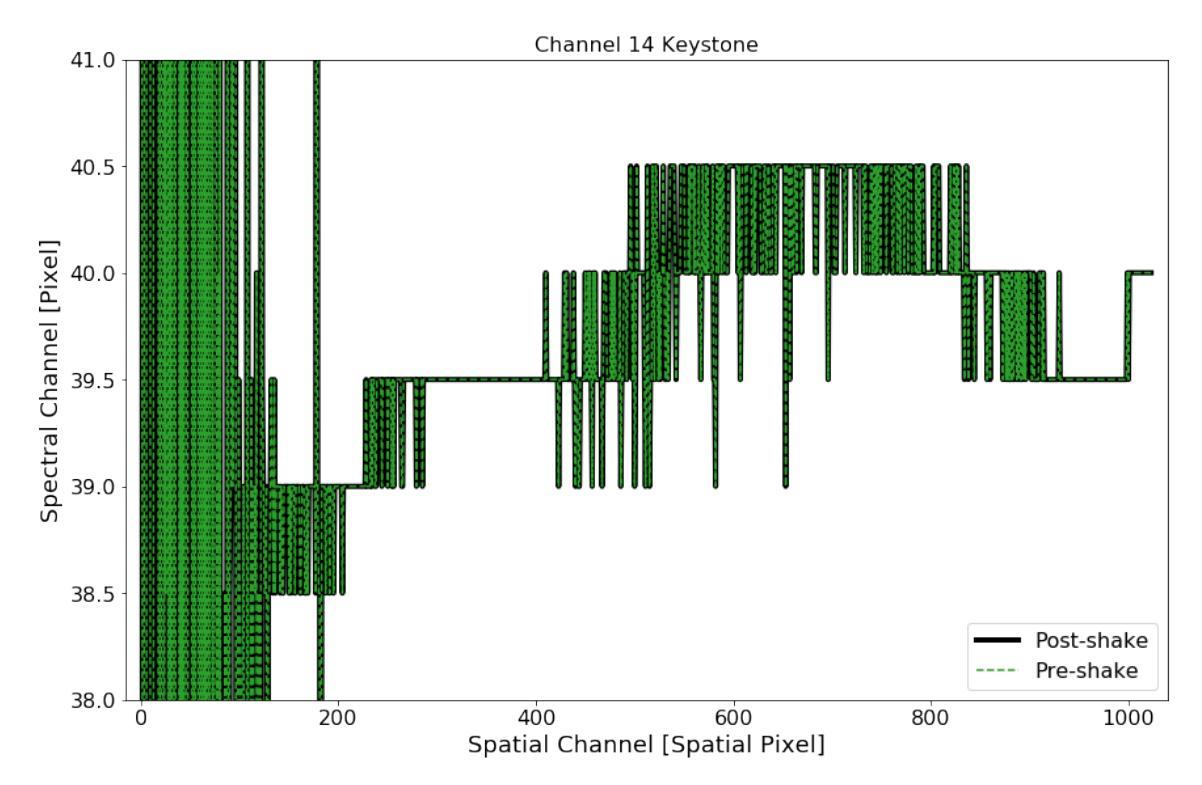
Figure 8: Channel 14 keystone.

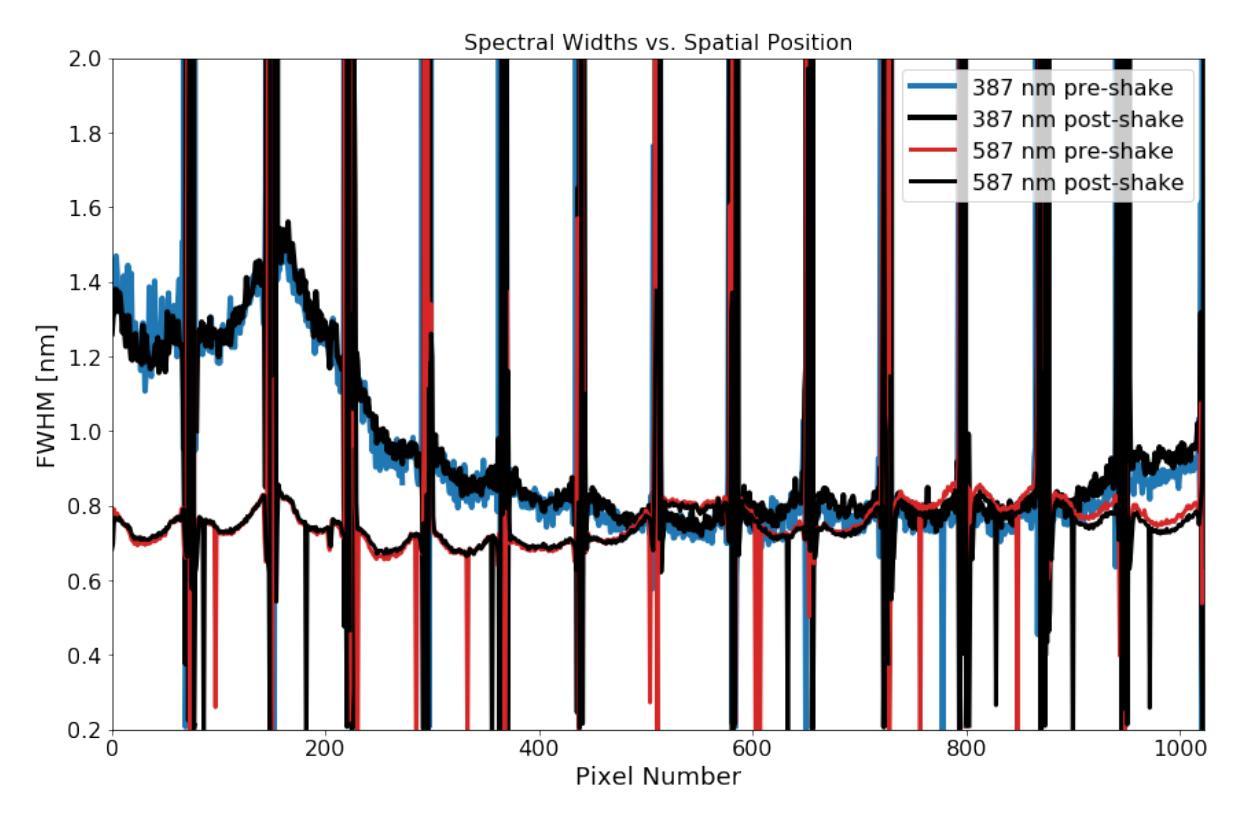
Spectral Resolution (FWHM)	
@ 587 nm	< 0.9 nm, See Figure 9
@ 387 nm	< 1.6 nm, See Figure 9

Figure 9: Spectral widths vs. spatial position

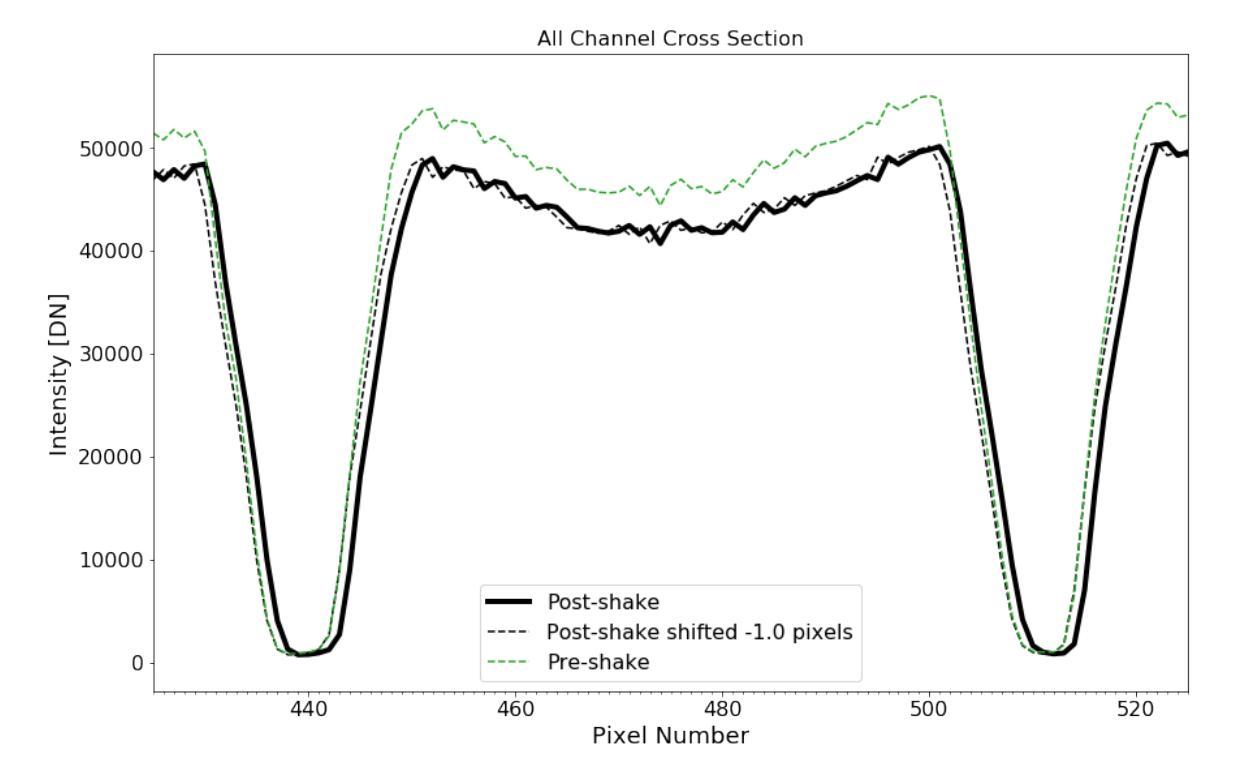
Figure 12: Cross section of fibers, spatial pixels 425-525.

in spatial channel position was observed post vibe, detailed in Figures 12 and 13 above. No movement was detected along spectral axis, nor rotation of the FPA about the optical axis, as no significant change was observed post-vibe in the smile and tilt/keystone plots shown in Figures 4-8.

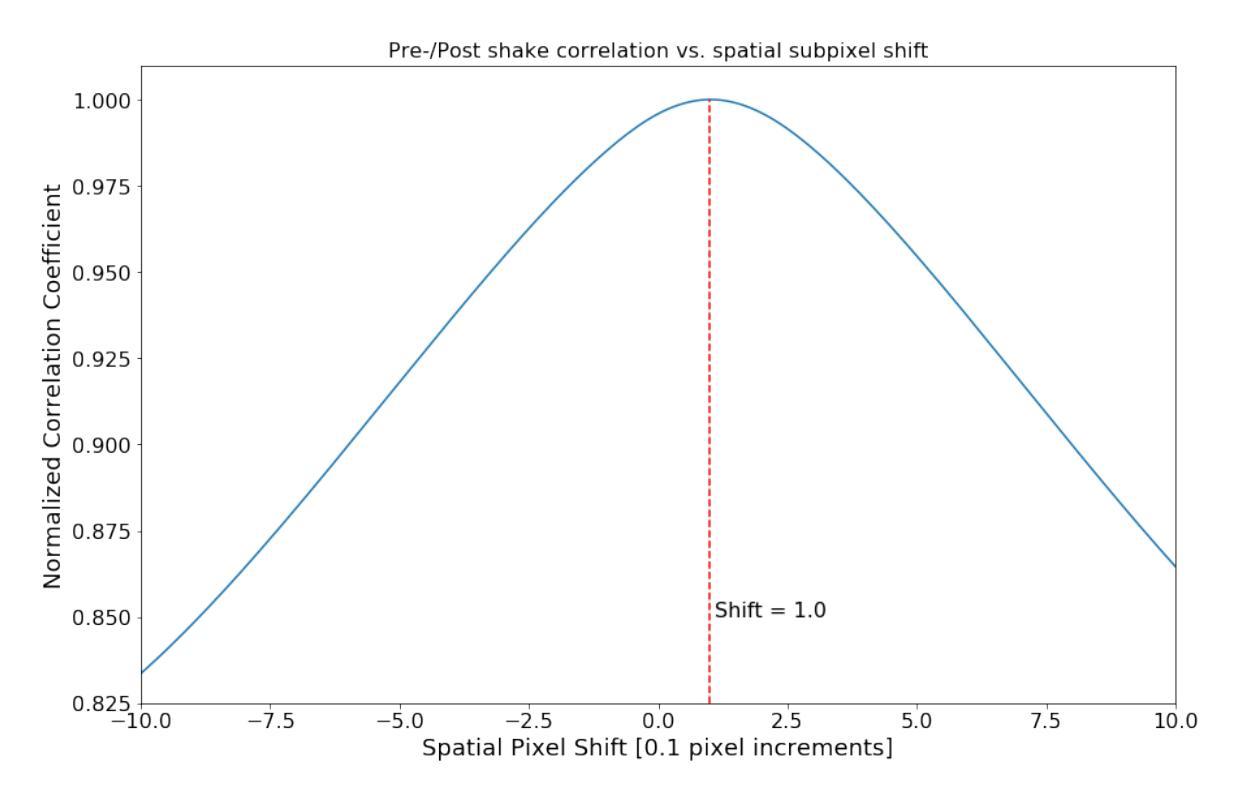
Figure 13: Sub-pixel correlation of post-shake all channel cross section to pre-shake all channel cross section showing a 1.0 +/- 0.1 pixel spatial shift.

The assembled instrument was subjected to a 4-hour vibration test. Evaluation of the instrument pre- and post-vibe shown in the above plots. A 1.0+/-0.1 pixel shift
